DOVE LAKE DAM

COLE COUNTY, MISSOURI

MO 30494

PHASE 1 INSPECTION REPORT NATIONAL DAM SAFETY PROGRAM

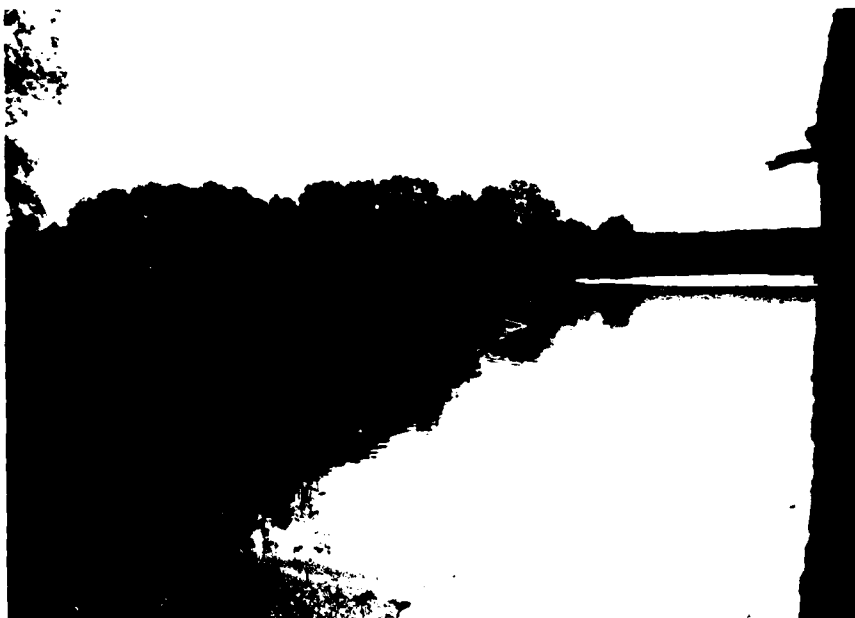
PHOTO 1: UPSTREAM FACE OF DAM LOOKING EAST

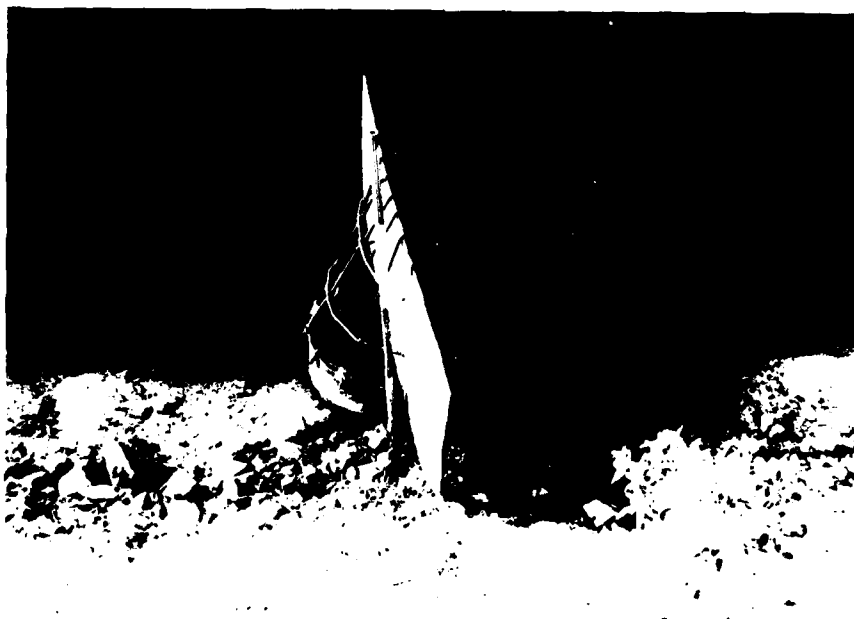
PHOTO 8: PRINCIPAL SPILLWAY DROP INLET
